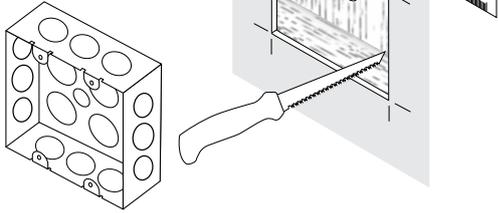
2 A

American Style

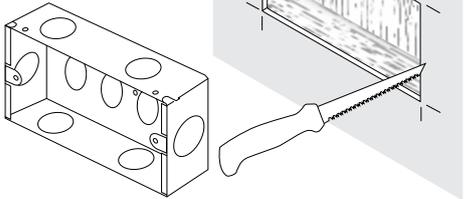
2 B

European Style

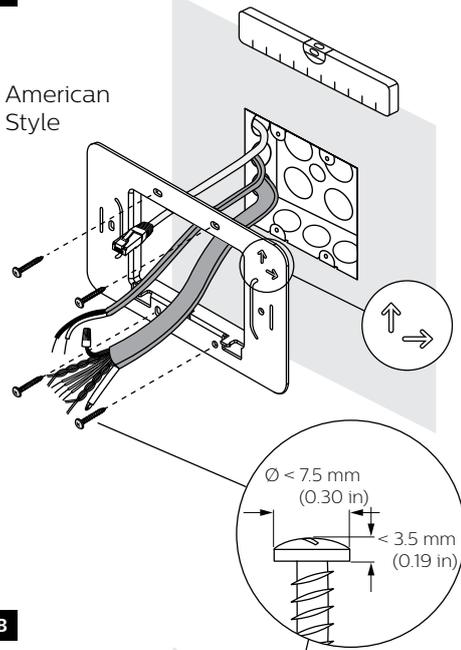
3 A

American Style

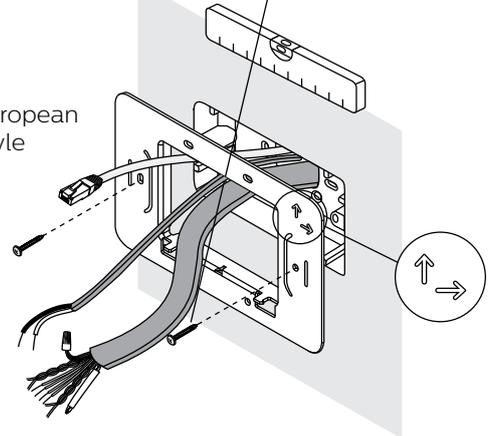
3 B

European Style

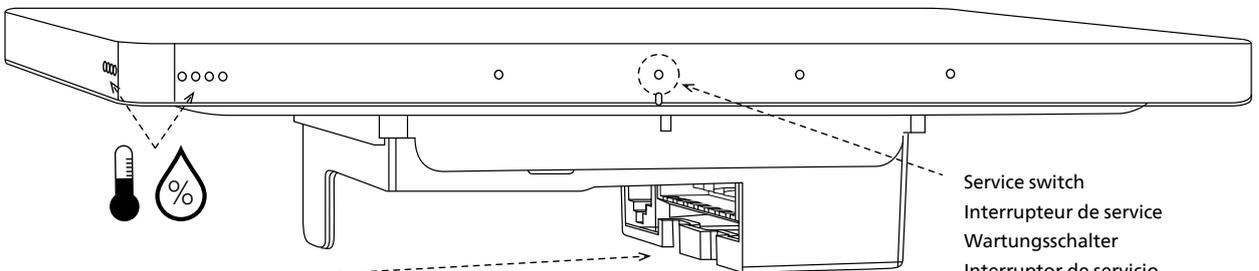
4

Cables enter from left side

Service switch

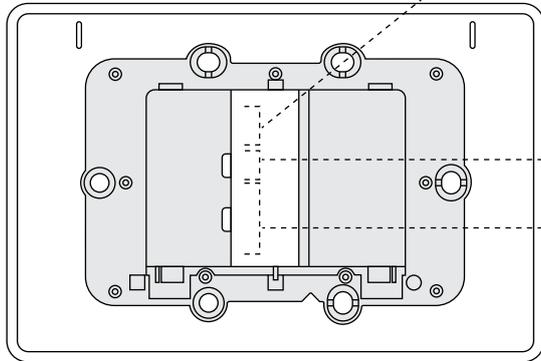
5

DDNP1501

DMNP24040-P-NA

THIRD PARTY

Required Supply: SELV/Class 2 (UL)
12 V \equiv 500 mA
24 V \equiv 300 mA

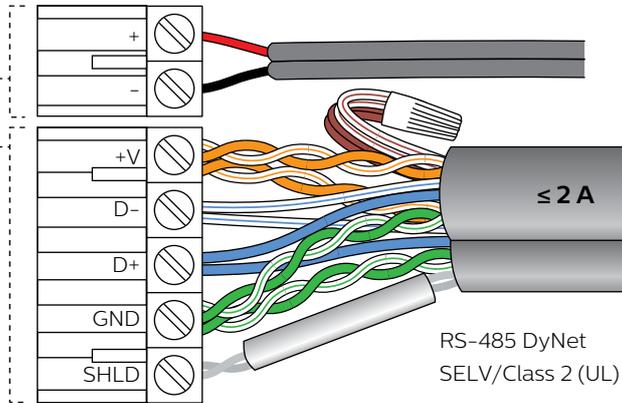
RS-485 DyNet
SELV/Class 2 (UL)
